## Roadway Inventory

Sheet: RD-40  
Roadway Inventory

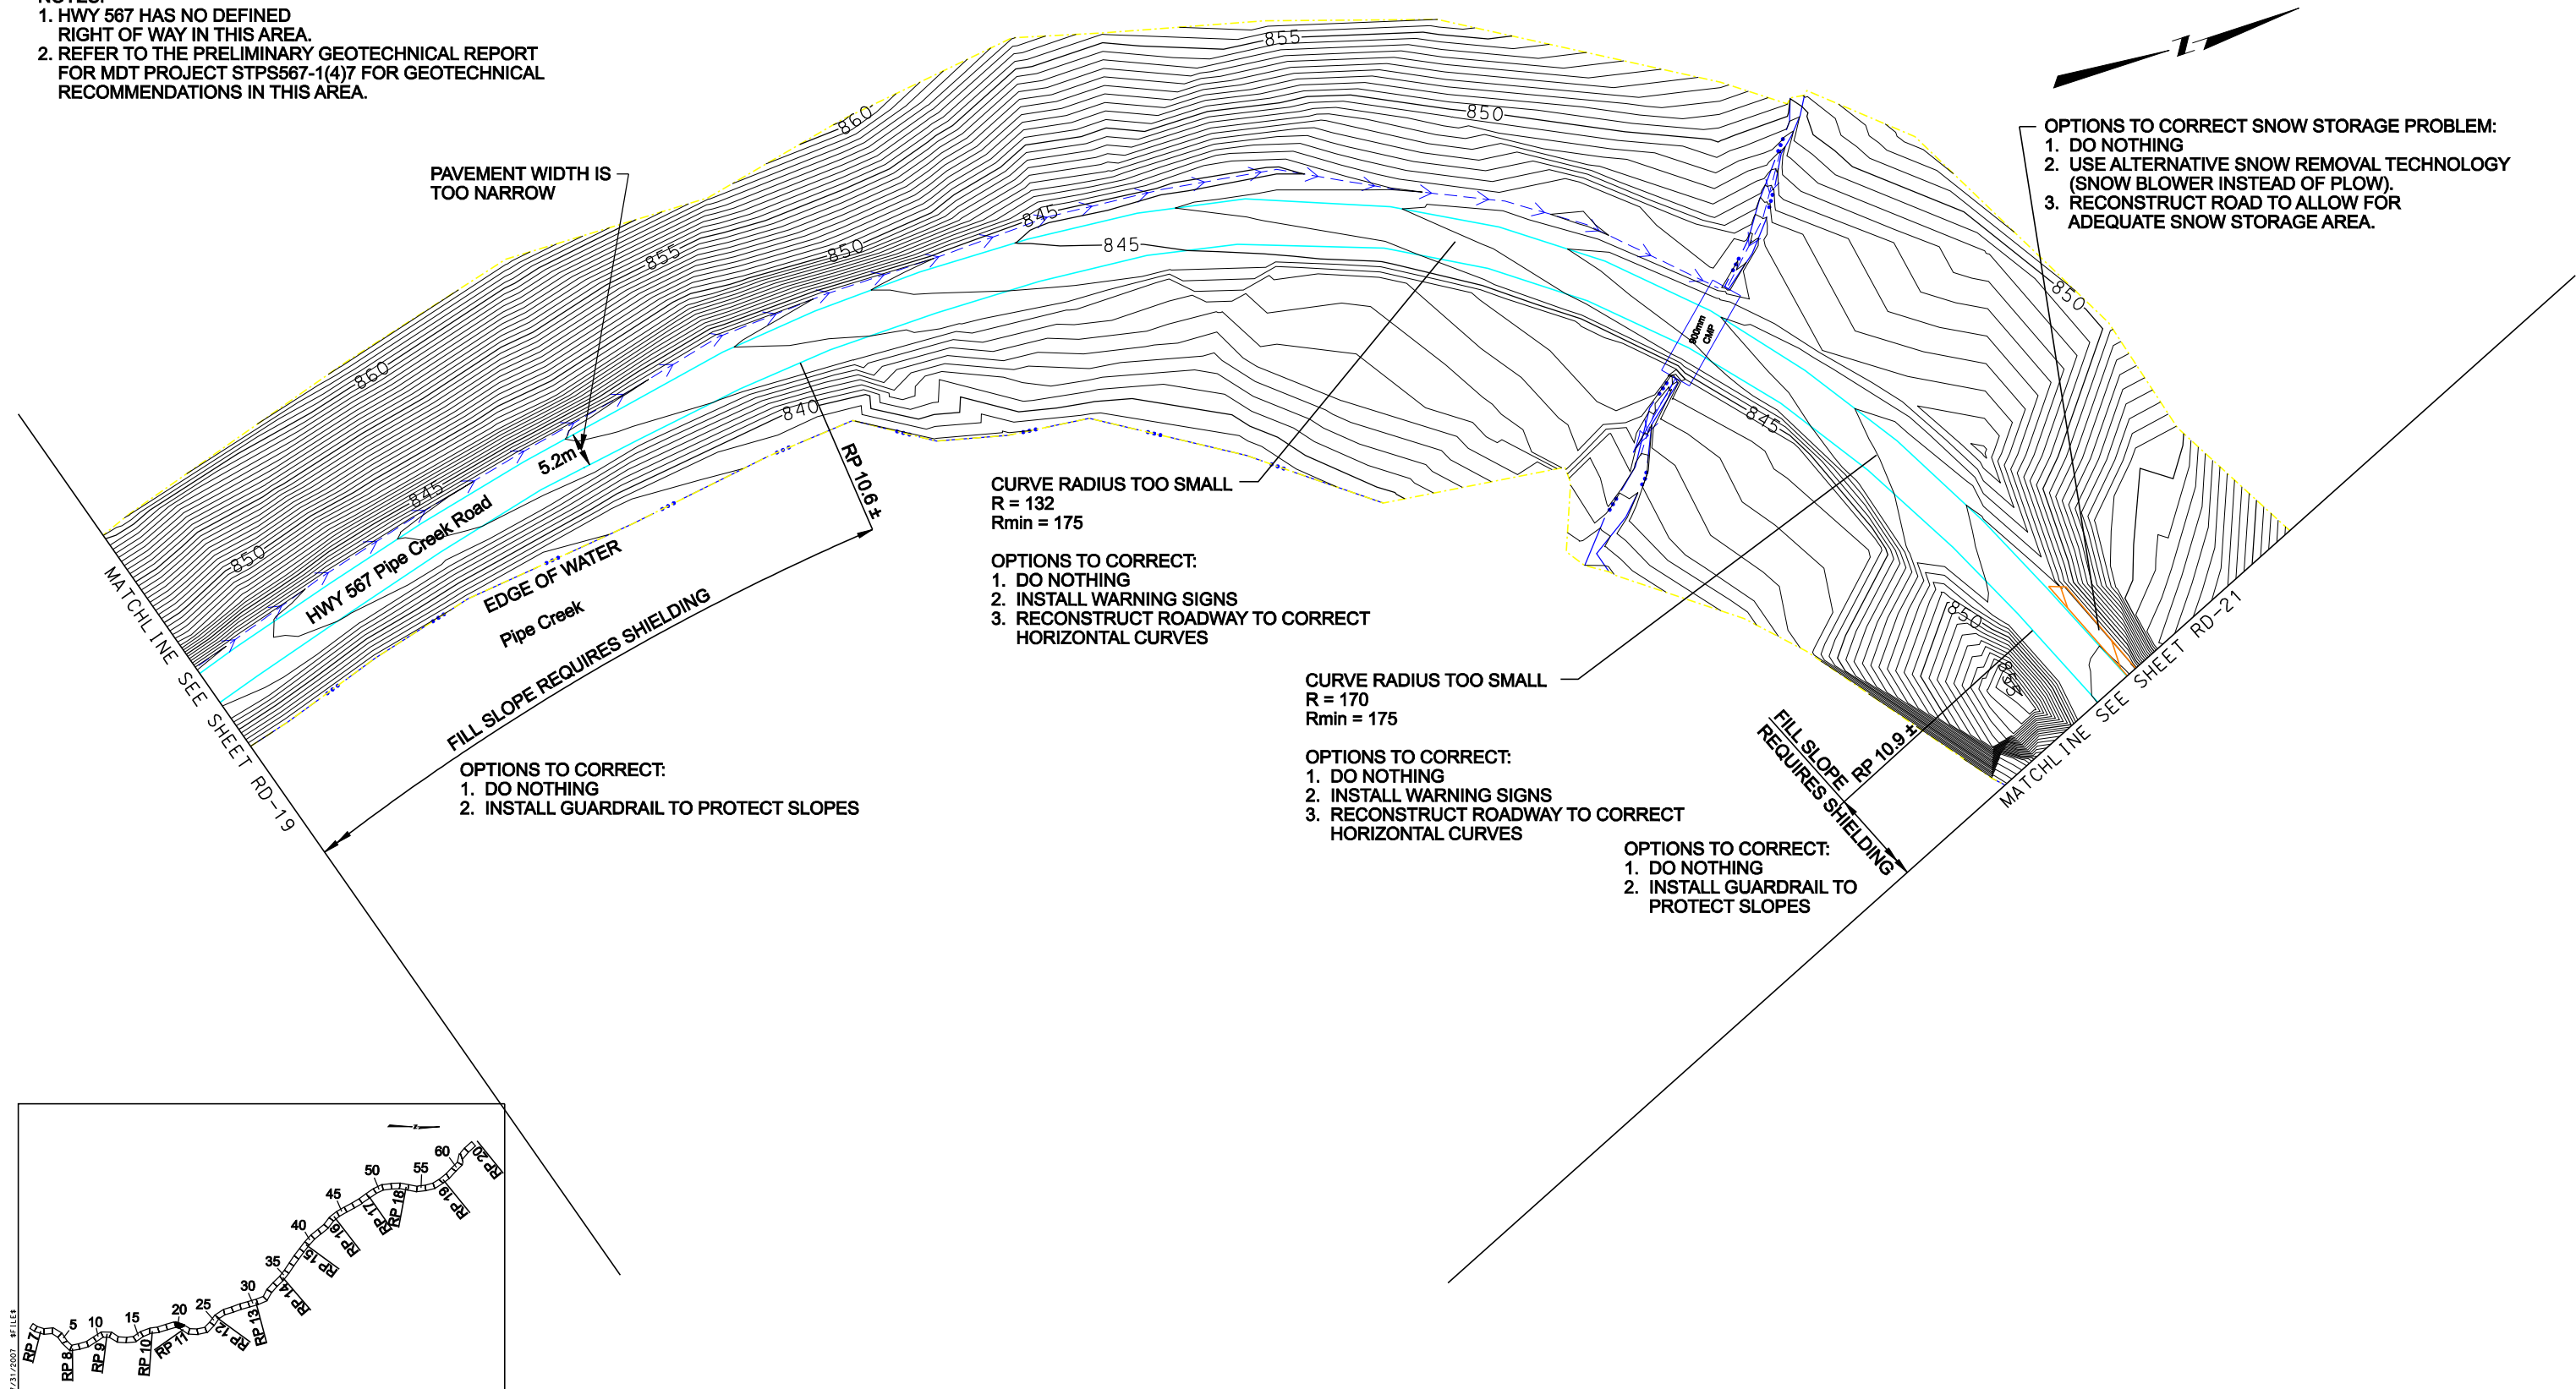
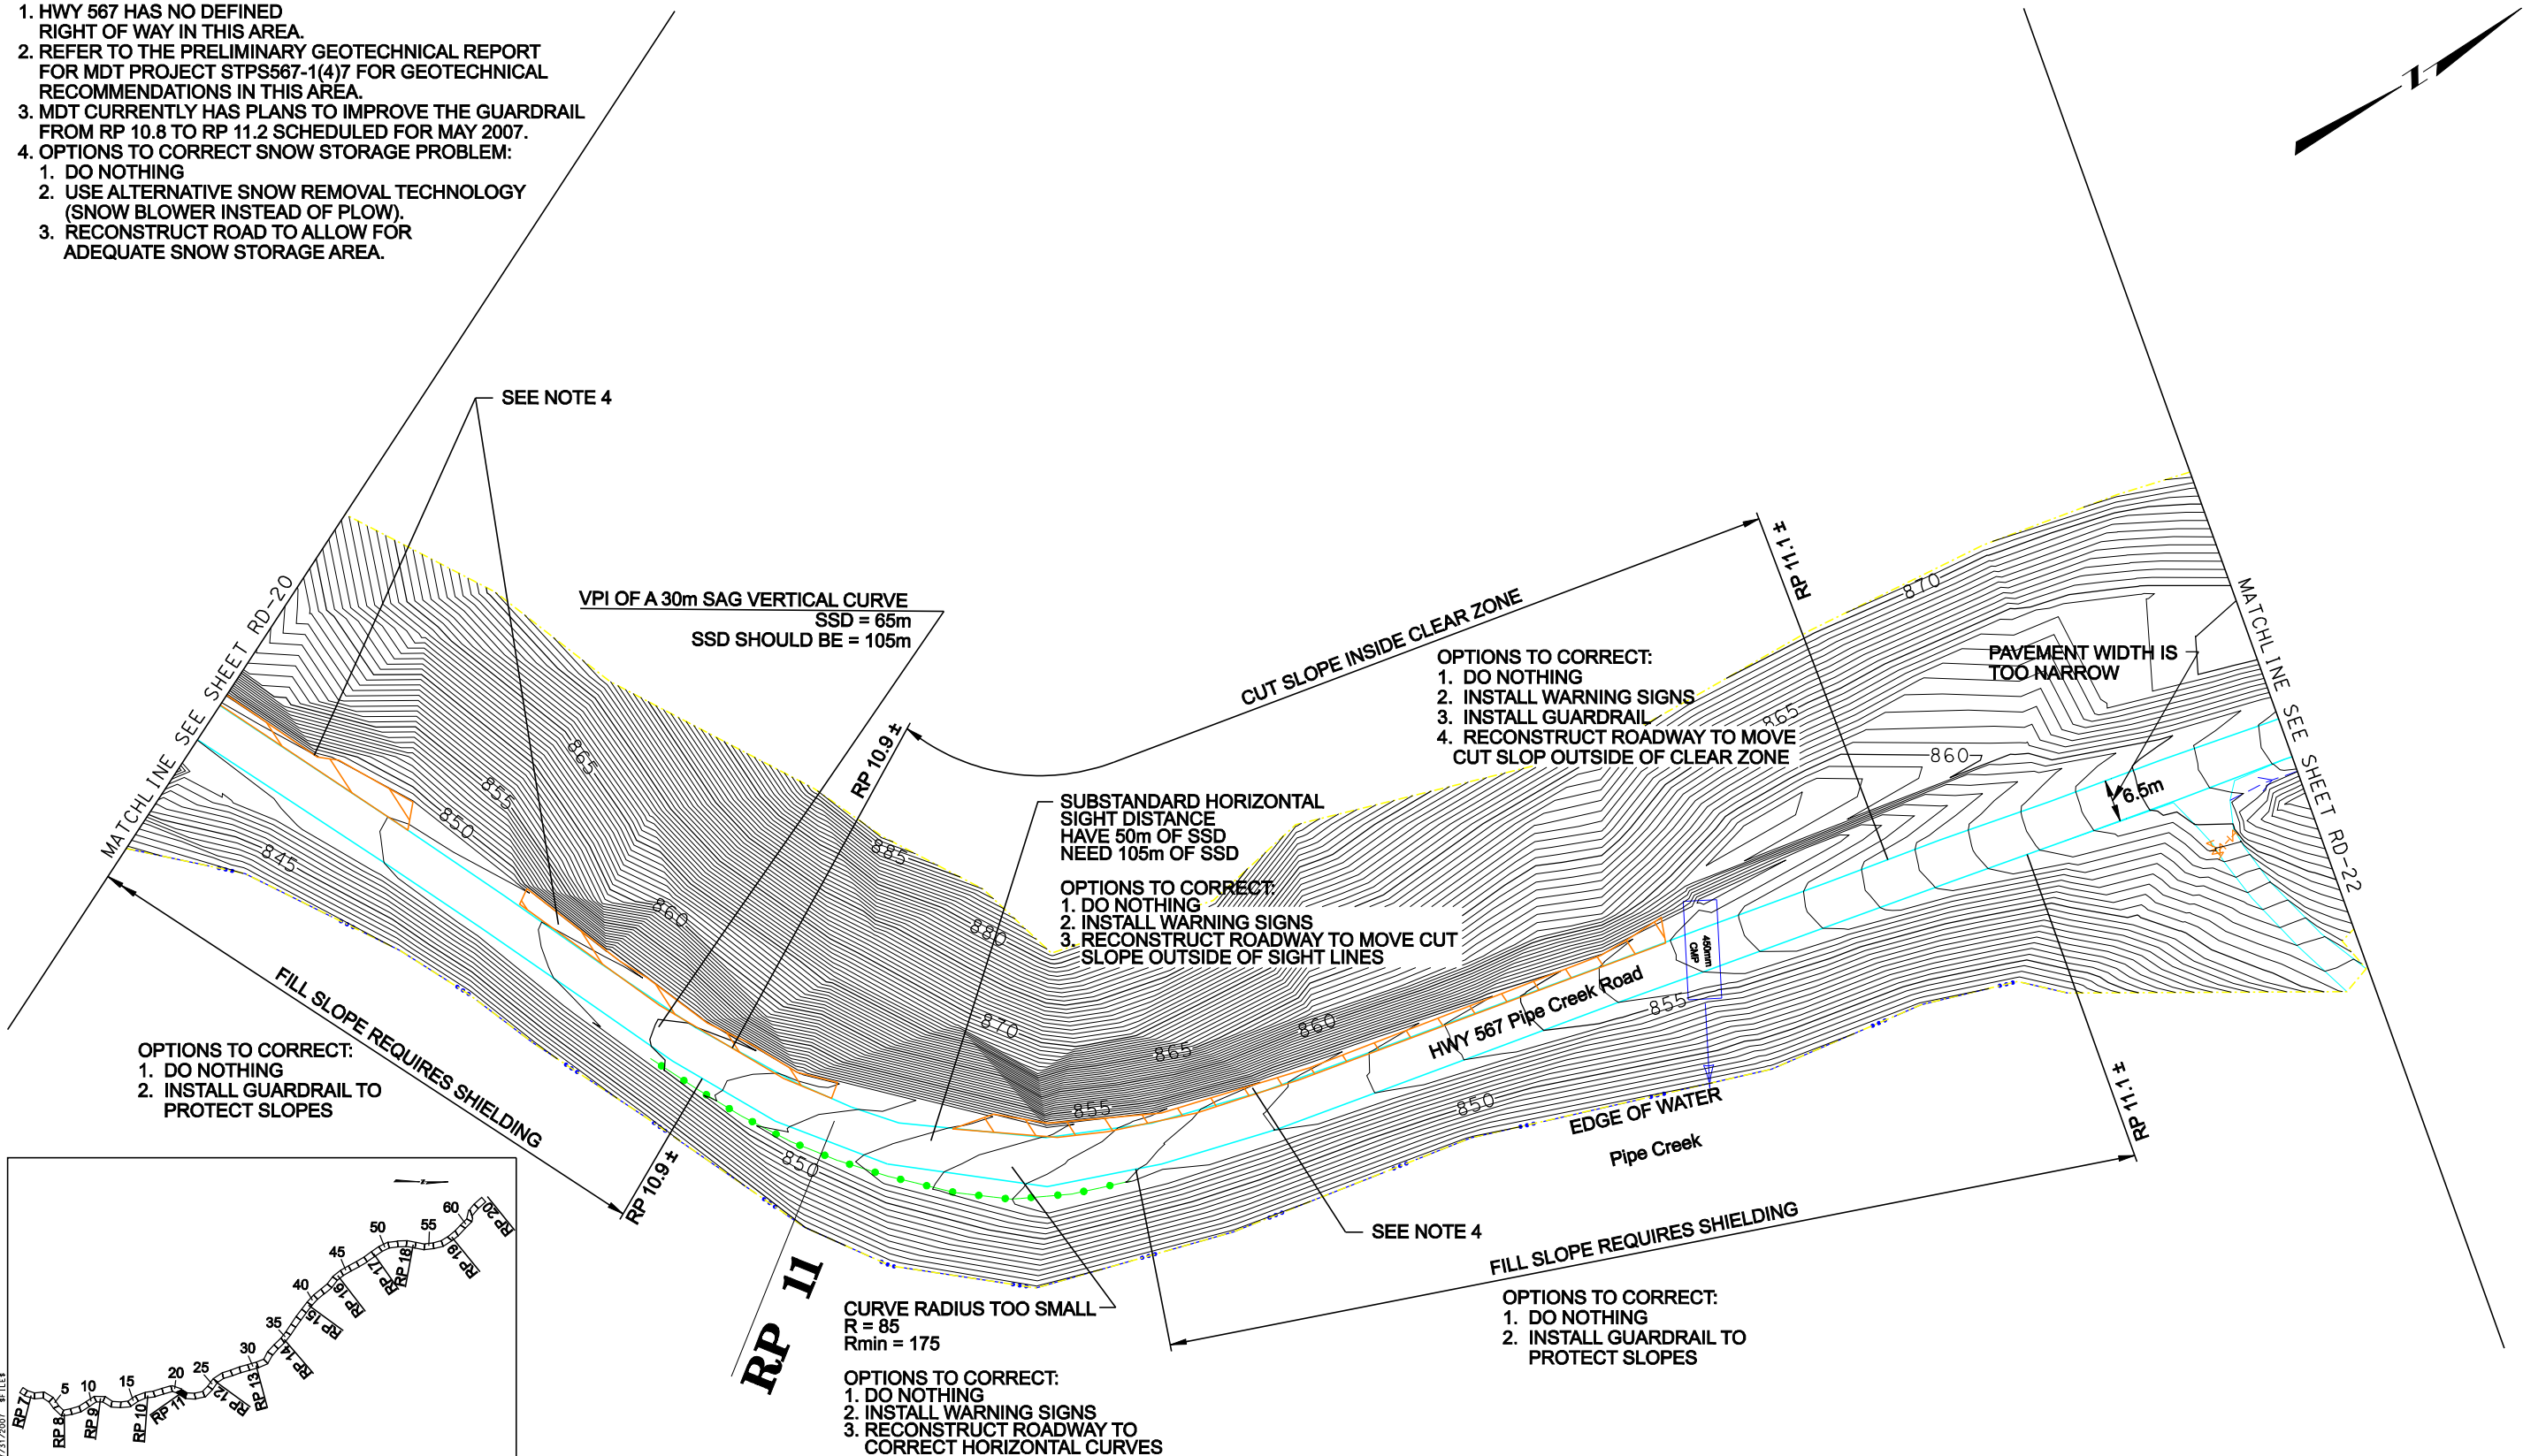
1. HWY 567 HAS NO DEFINED RIGHT OF WAY IN THIS AREA.
2. REFER TO THE PRELIMINARY GEOTECHNICAL REPORT FOR MDT PROJECT STPS567-1(4)7 FOR GEOTECHNICAL RECOMMENDATIONS IN THIS AREA.
3. MDT CURRENTLY HAS PLANS TO IMPROVE THE GUARDRAIL FROM RP 10.8 TO RP 11.2 SCHEDULED FOR MAY 2007.
4. OPTIONS TO CORRECT SNOW STORAGE PROBLEM:
  1. DO NOTHING
  2. USE ALTERNATIVE SNOW REMOVAL TECHNOLOGY (SNOW BLOWER INSTEAD OF PLOW).
  3. RECONSTRUCT ROAD TO ALLOW FOR ADEQUATE SNOW STORAGE AREA.

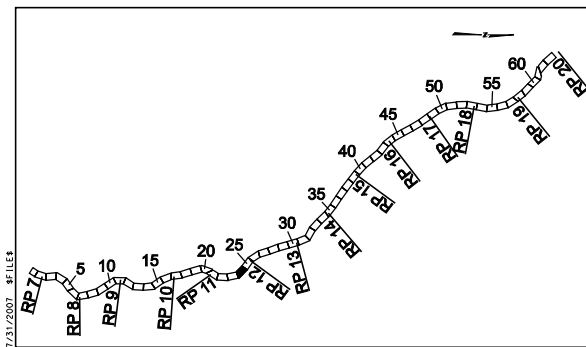
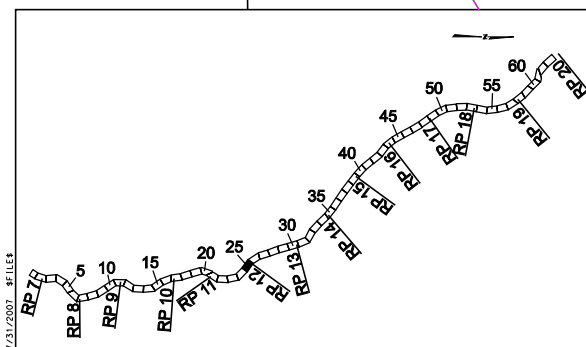
RP 12

PAVEMENT WIDTH IS  
TOO NARROW

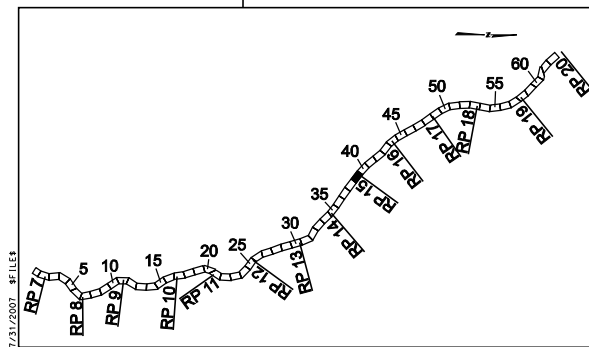
RP 15

PAVEMENT WIDTH IS  
TOO NARROW

5.8m
